## SOME ENGINEERING GEOLOGIC EFFECTS OF THE 1964 ALASKA EARTHQUAKE

Wallace R. HANSEN (\*)

### ABSTRACT

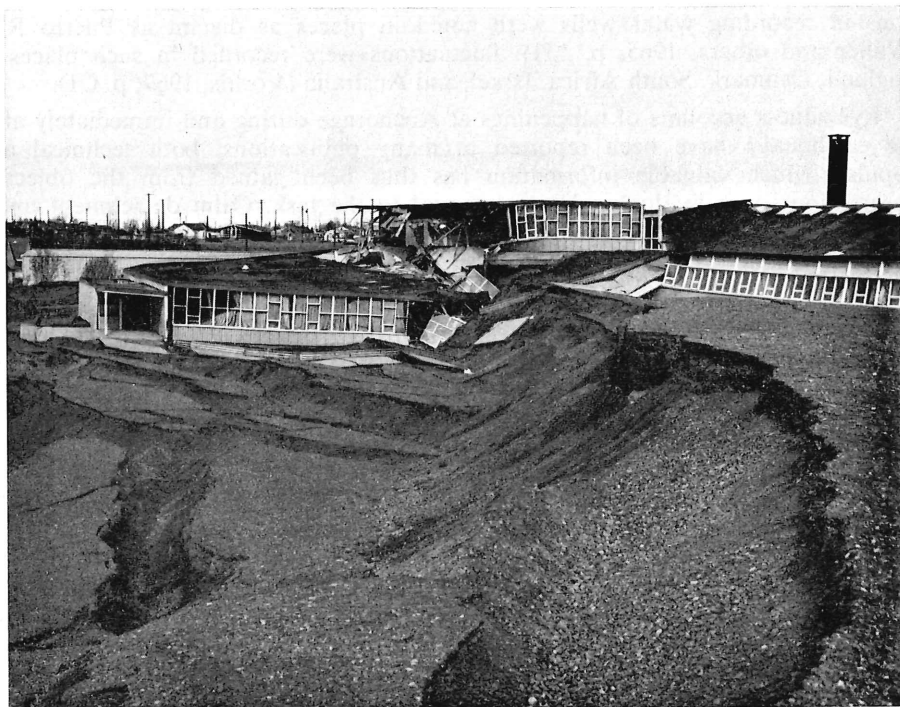
The school system was hard hit. Fortunately, classes were not in session, so the buildings were empty. Early estimates of damage came to about \$3.86 million. One school building was severely damaged and another was a total loss (fig. 2). Of the 26 schools in Anchorage, 20 were soon back in operation.

FIG. 2. — *Government Hill Elementary School, destroyed by landslide.*

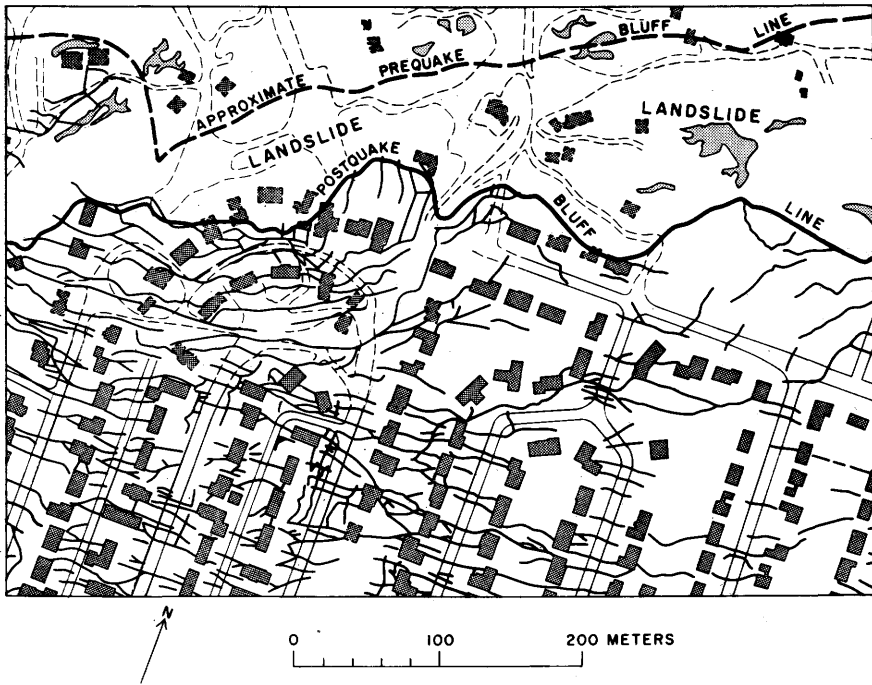
The most severely cracked ground was adjacent to landslides or within slide areas where cracks were caused by tension directly related to sliding. Much structural damage in build-up areas was caused by such ground cracking. At Turnagain Heights, for example, severe cracking extended at least 670 m back from the head of the landslide, completely through the residential subdivision, badly damaging scores of houses (fig. 3).

FIG. 3. — Map showing the pattern of ground cracks at Turnagain Heights. Part of the landslide is at the top of the map (from Hansen, 1965, pl. 1).

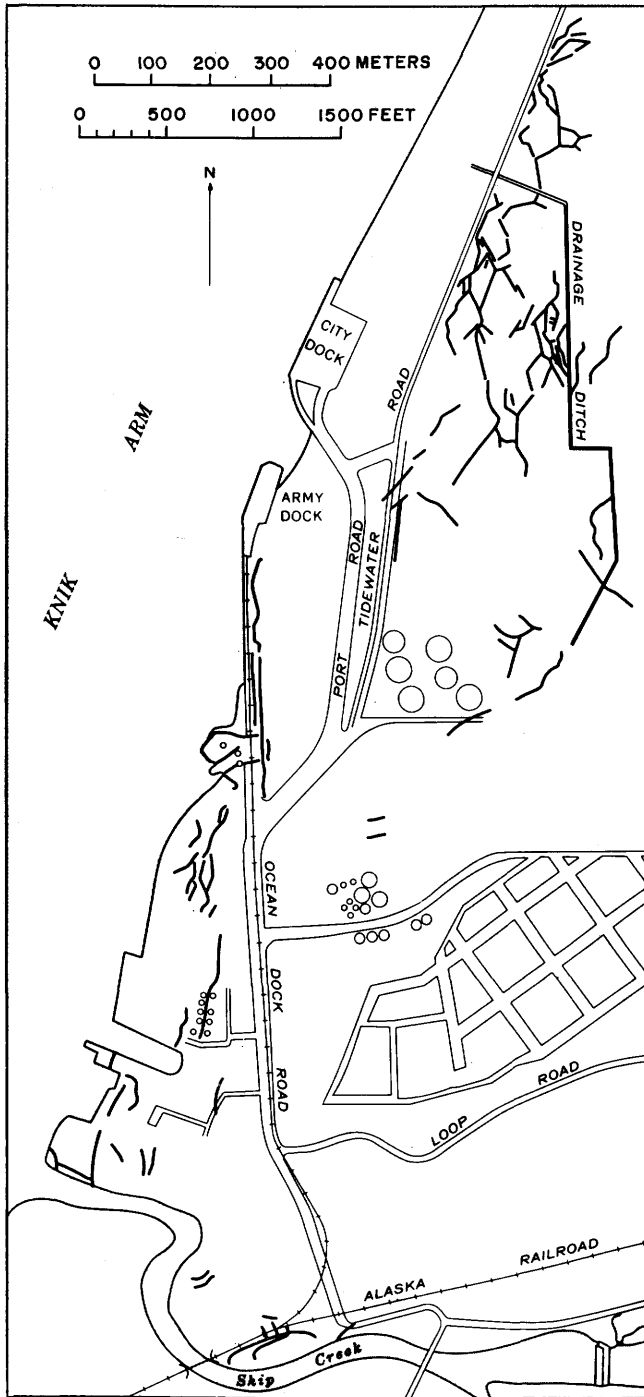
FIG. 4. — Ground cracks, Port of Anchorage and vicinity. Many of these cracks spouted mud, particularly those east of City Dock. Base by City of Anchorage, Office of City Engineer.

In the Anchorage area mud fountains or sand boils were abundant (1) on or near to cracked tidal flats adjacent to Knik Arm, especially in the vicinity of the Port of Anchorage at the mouth of Ship Creek, (2) in association with some landslides, (3) around the shores of ice-covered lakes, and (4) in other settings of fractured ground (fig. 4).

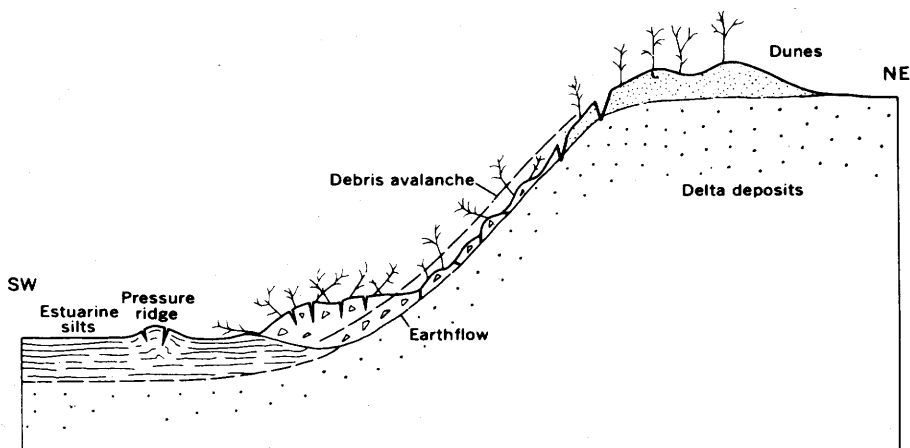
Structurally, the simplest slides were in the bluffs facing Turnagain Arm south-east of Point Campbell (fig. 5). There, a thin cover of wind-blown sand and

FIG. 5. — Diagrammatic section near Point Campbell, showing mode of failure along bluff line overlooking Turnagain Arm. Bluff is about 75 m high.

slope wash had been loosely anchored to the steep face of the bluff by an overgrowth of trees, shrubs, and grasses. The entire superficial mat slumped downward a few inches to several feet along the full length of the bluff from Point Campbell to Campbell Creek, a distance of about 6 km. Locally the slumping was more intense, and the face of the bluff was laid bare from top to bottom. Southeast of Campbell Creek, minor slumping and cracking extended along the bluff to the tracks of the Alaska Railroad near Potter, where slides destroyed trackage and embankments.

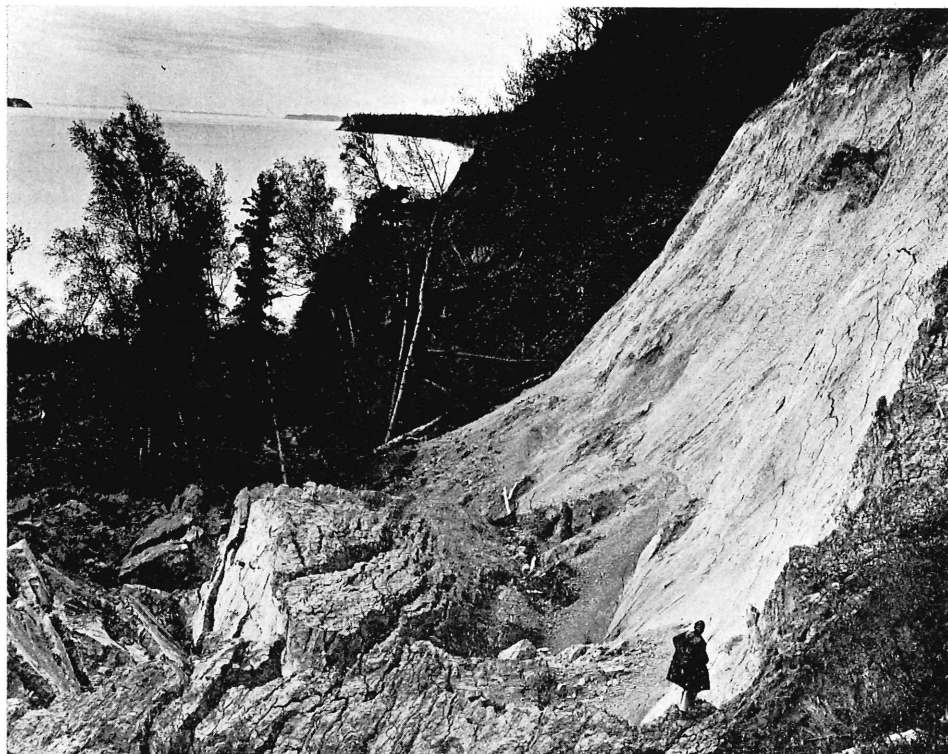
FIG. 6. — Large slump on west side of Knik Arm near Sleeper. Headwall scarp at right—foreshortened in this view—is more than 80 m high.

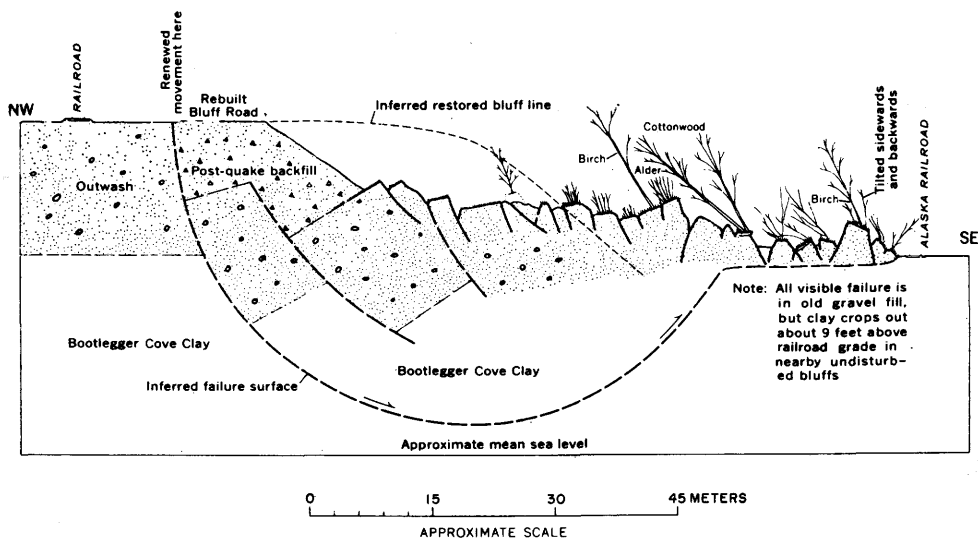
Several rotational slides gave way along the south-facing bluff line of Ship Creek, between Bluff Road and the tracks of the Alaska Railroad (fig. 7). The broadest failure there extended about 390 m along the bluff in four separate but connected slumps. These slumps would have been very destructive if they had failed in a built-up area. As it was, the outer rim of the bluff dropped about 12 m, rotating backward  $15^{\circ}$ - $30^{\circ}$  and destroying about 200 m of highway along the rim of the bluff. The toe of one slump flowed across the tracks of the Alaska Railroad

FIG. 7. — Sketch section through rotational slide at Bluff Road.

Most of the visible landslide material was coarse outwash gravel, but failure in the Bootlegger Cove Clay probably was the chief cause of sliding. Bootlegger Cove Clay was exposed along a line of springs 3 m above the base of the slope of the bluff just west of the slides, and it must have extended under cover of colluvium into the slide area (Trainer and Waller, 1965, fig. 3 B). Its loss of strength under the vibratory motion of the quake must have contributed to the failure of the slopes below the bluff and to the flowage of material from the toe of the slides.

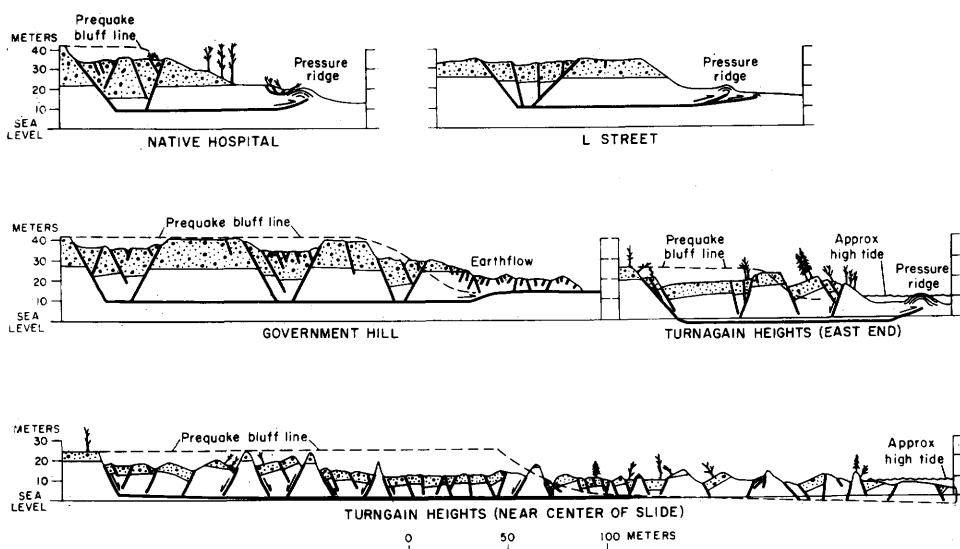
FIG. 8. — Cross sections through some translatory landslides, Anchorage, Alaska.

They slid laterally on nearly horizontal slip surfaces following drastic loss of strength in previously weak sensitive zones of the Bootlegger Cove Clay. Slides in which the slid mass was practically intact could be classed as "block slides"; those in which the slid mass underwent appreciable disruption are probably best classed as failures by lateral spreading (Varnes, 1958, pl. 1). Between these limits, all gradations of form were represented—not only from place to place but also in time. Structurally the "L" Street slide was the simplest and the Turnagain Heights slide was the most complex. The Turnagain Heights slide must have begun as a simple though highly transient block glide, or perhaps as several such block glides, arising independently along the bluff line. As sliding progressed, the Turnagain Heights slide deteriorated rapidly into a complex failure involving simultaneous translatory, sideward, and rotational motions (fig. 9). Its predominant motion, however, remained translatory. Destruction to property in the several

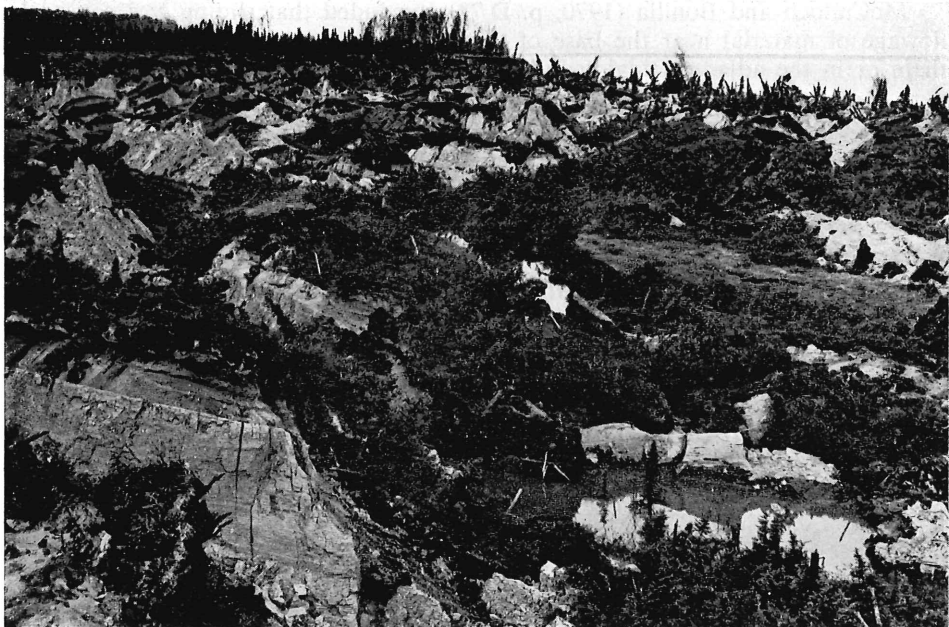
FIG. 9. — *Severe ground disruption caused by Turnagain Heights landslide. Original land surface intact, upper left. Knik Arm of Cook Inlet, upper right.*

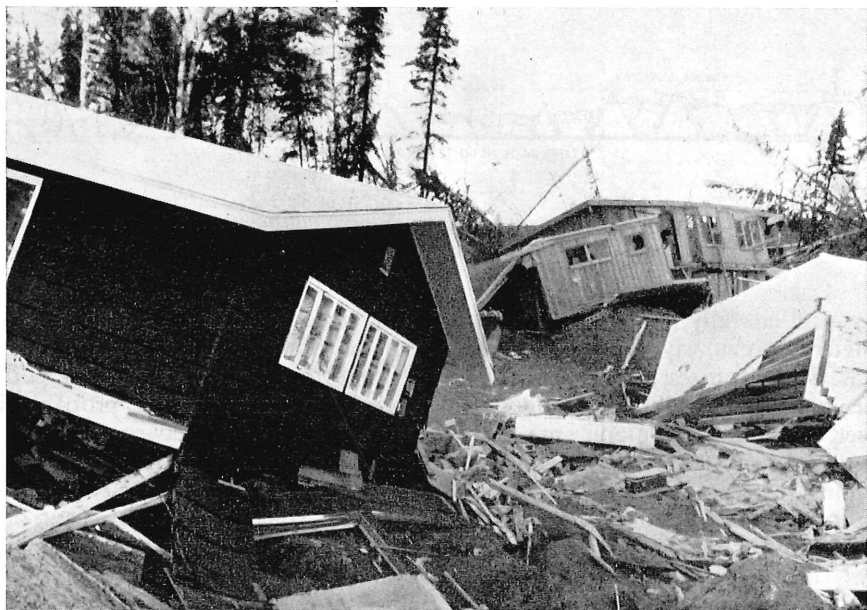
FIG. 10. — *Private homes demolished by Turnagain Heights landslide. Seventy-five houses were destroyed in this slide; dozens more were severely damaged.*

slides was caused by tilting, wrenching, warping, and disruption of structures over the cracked, collapsed, and compressed zones of the slides (fig. 10). In undistorted parts of some slides even large buildings were little damaged despite horizontal ground translations of more than a meter.

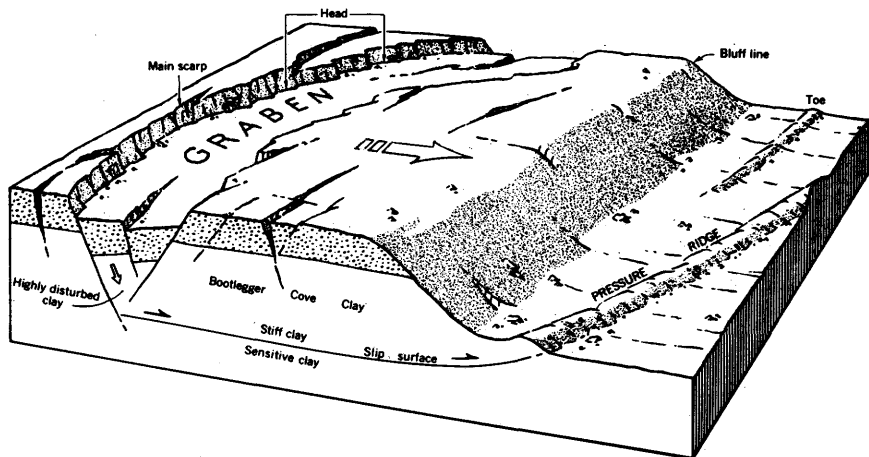
Translatory slides of the Anchorage area varied widely in size, shape, and internal complexity, but they all conformed to a single basic geometric form (fig. 11). In plan, each slide was bounded laterally by a series of crescentic tension fractures, which also marked the outer wall of the outermost graben. Other tension fractures—bounding potential slide blocks—commonly extended headward, outside the slide proper, scores of hundreds of meters beyond the bounding fractures. At Turnagain Heights, numerous crescentic tension fractures extended back through the subdivision as much as 660 m beyond the head of the slide. Had the earthquake lasted longer, sliding undoubtedly would have retrogressed back into that area. "Retrogression," as applied to landslides, means a headward expansion of the slide.

FIG. 11. — Block diagram of a translatory landslide, as exemplified by the "L" Street slide.

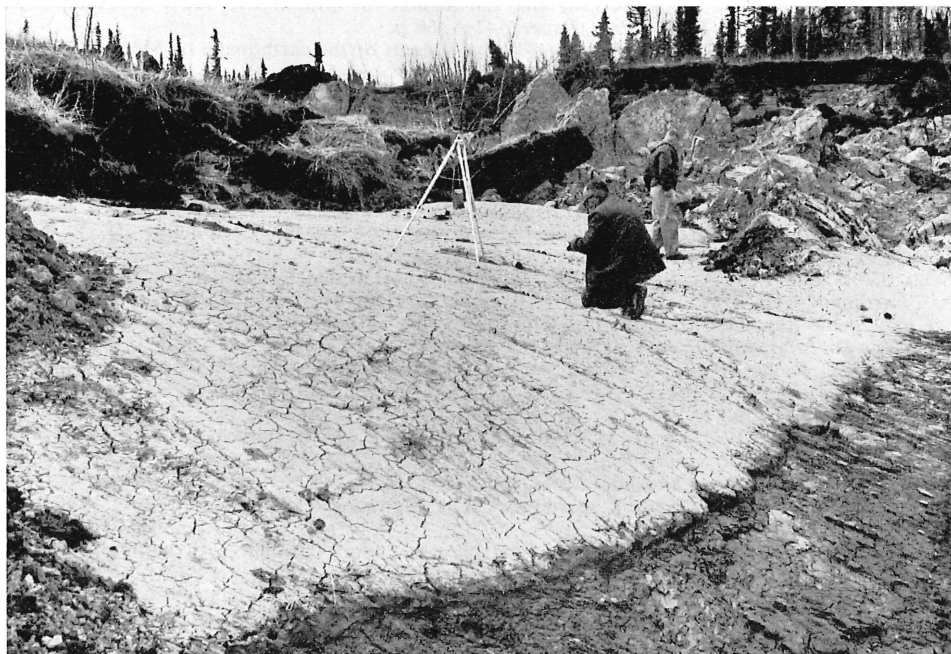
FIG. 12. — Slip surface of the Turnagain Heights landslide exposed near tidewater at west end of slide. Landslide blocks slid freely down this surface into tide water. Dark area to lower right is inundated at high tide. Dark material at upper left is peat and muskeg, which was lowered onto slip surface when clay slid and flowed out from beneath it.
