A DPRK missile in Ukraine: results of an inspection by UN Panel experts

Abstract

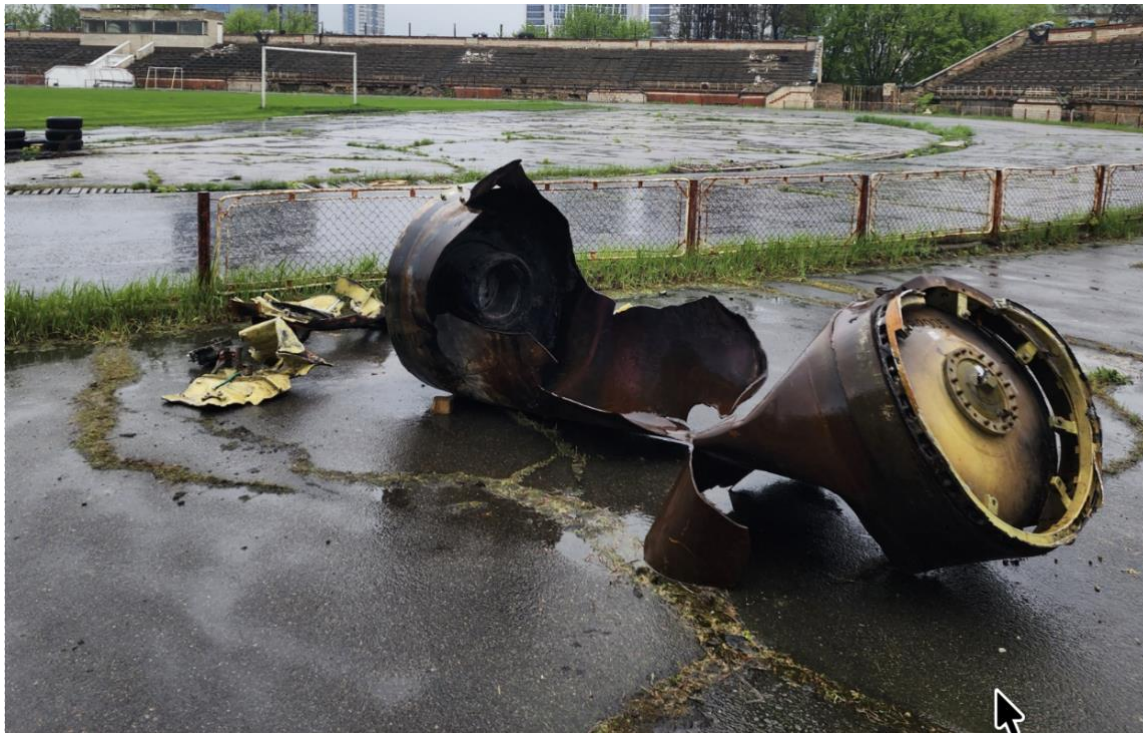
Figure 1. Missile airframe debris laid out by Ukrainian authorities for inspection by Panel experts. The front end of the engine (to the right), the rear end of the engine (to the left), and related components scattered on the ground further to the rear constituted the majority of the debris. The warhead would have been located on the front end of the engine. Source: authors' image.

The experts' subsequent inspection took place at two sites in Kyiv. Missile body parts, including the front and rear parts of a solid fuel engine, three aerodynamic rudders, three gas dynamic rudders (actuators, jet vanes), as well as parts of the cable duct were examined at a Ministry of Defense site on April 17 (Figure 1).

The experts measured the diameter of the forward end of the engine (Figures 1 and 3) and, taking distortion due to damage into account, estimated this to be about 92 cm. This dimension is somewhat larger than a published estimate of the diameter of Hwasong-11 series missiles (about 85 cm, see Figure 4).

Based on their own measurements and taking into account the damage to the missile and distortion of its frame, the experts estimated the diameter of the rear end of the engine (Figure 1) was about 110 cm. This

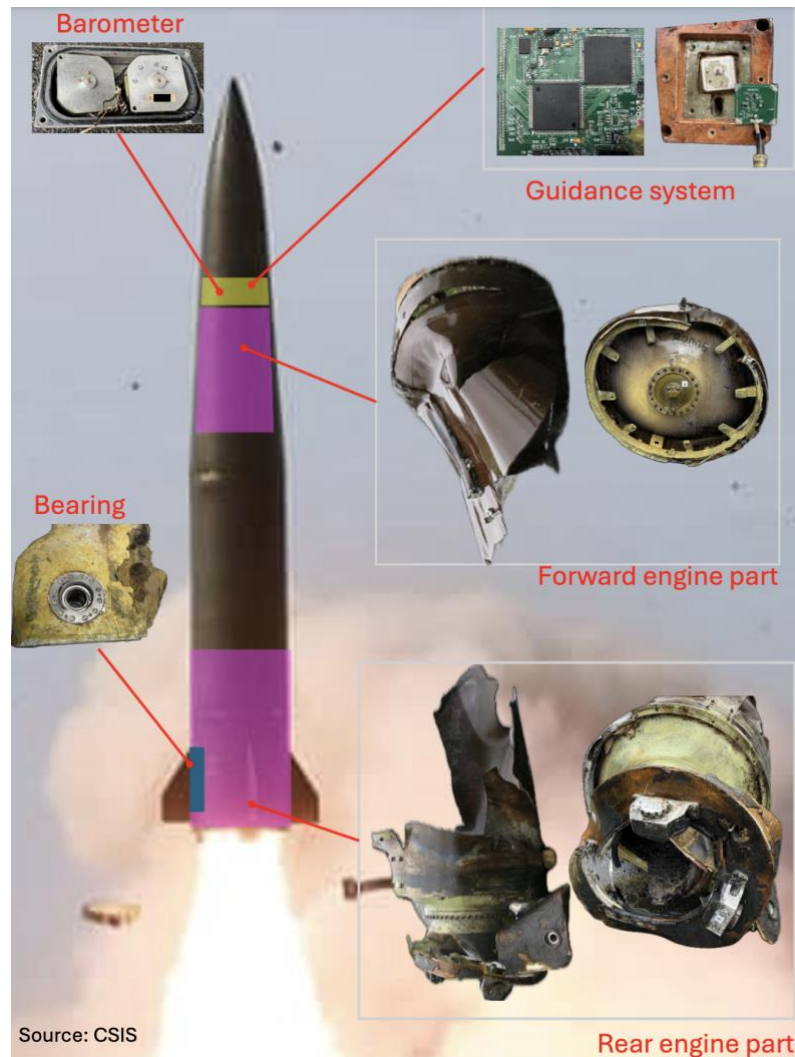
Figure 2. The approximate locations in the missile of the airframe debris and some of the components inspected by the experts. The elements of the guidance system, for example, fitted into the cavities and housings seen in Figure 7. Source: CSIS Missile Defense Project <<https://missilethreat.csis.org/missile/kn-23/>> (accessed December 21, 2025), modified by the authors.

Figure 2 shows the approximate location of some of the body parts on the missile itself.

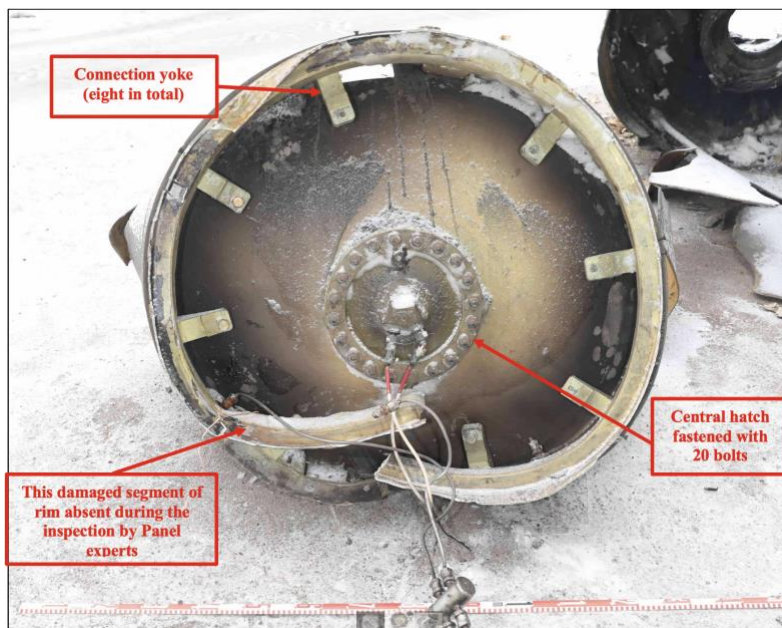
Figure 3. The front section of the rocket motor inspected in Kyiv by the Panel experts on April 17, 2024. The image is courtesy of Conflict Armament Research (CAR) whose field investigators documented the missile in Kyiv on January 11, 2024². By the time the experts conducted their own inspection some areas of the rocket motor had been cleaned up, and the damaged segment of the rim seen here had broken off or had been removed. Annotations have been added to CAR's image based on the authors' observations during their inspection. Note the eight connection yokes and twenty bolts (see also Figure 7).

Eight connection yokes were built into the top of the forward end of the engine, distributed around the inside of the rim (see Figure 3). A similar configuration of connection yokes can be seen on the forward section of motor casings of Hwasong-11 series missiles in the February 11 Plant (Figure 6).¹⁸

Twenty bolts were fixed in a circle to the hatch at the top of the forward end of the missile engine (see Figure 3). This configuration of bolts and the design of the assembly match equivalent features seen on bodies of Hwasong-11 series missiles at the February 11 Plant (Figure 7).

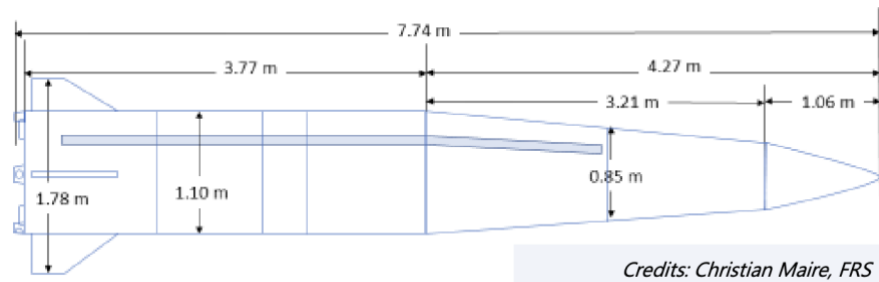
Figure 4. Estimates of the possible dimensions of one of the Hwasong-11 variants (KN-23) (see figure 18 of footnote 16).

dimension is consistent with published estimates of the width of the rear of Hwasong-11 series missiles, between 110 cm (as in Figure 4¹⁵) and 95 cm.¹⁶ The dimension is larger than the estimated equivalent width of the Russian Iskander M (92 cm).¹⁷

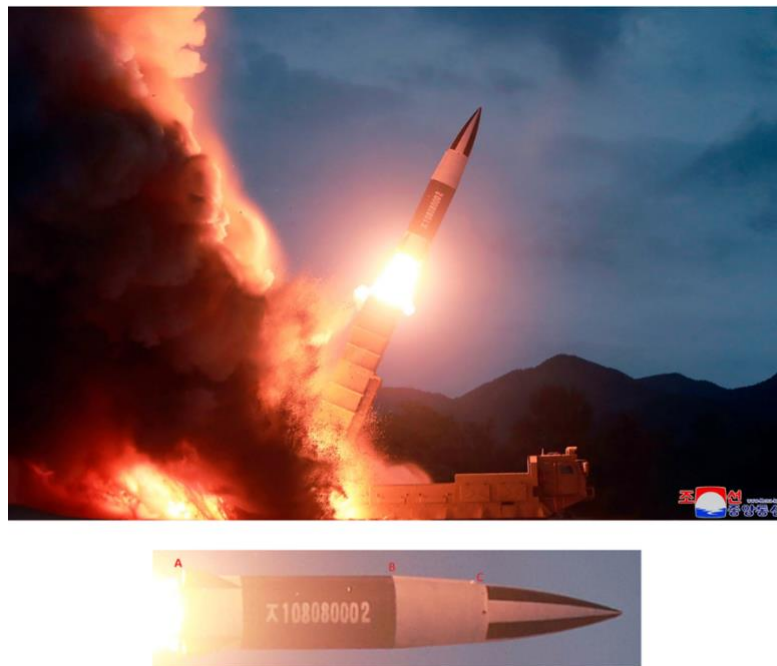
Figure 5. Top: Launch of a Hwasong-11B missile (Source: KCNA). Bottom: Enlarged image of the missile. If we assume that the diameter of the base of the missile (point A) is 110 cm (as measured by the Panel experts in Kyiv) and that this diameter remains constant along the length of the missile's body to point B (as indicated in Figure 4), then based on the proportions of this image the diameter of the forward end of the engine (point C) is about 91.2 cm. Within the margins of error of this exercise this diameter is equivalent to that estimated by the experts, based on their measurements (92cm).

It is however consistent with the diameter we estimate of a Hwasong-11B photographed in flight (about 91.2 cm, see Figure 5).

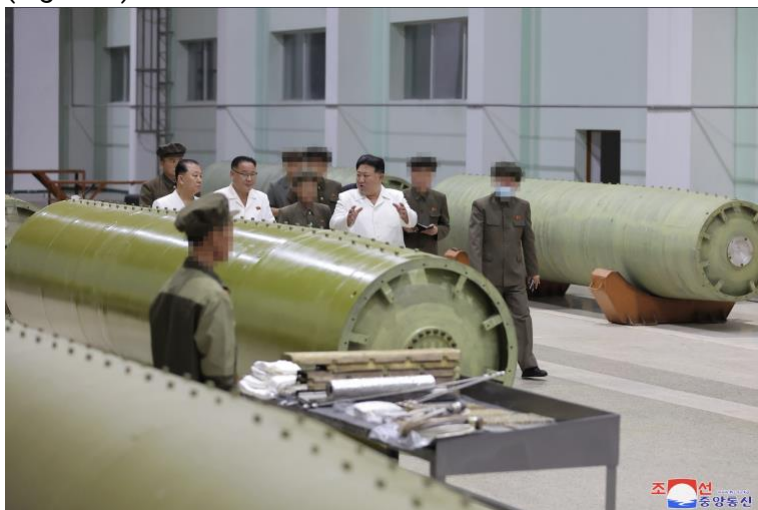
Figure 6. The forward end of Hwasong 11 series missile bodies, with their eight connection yokes. Note cable-duct fixings running along the length of the top surface. Source: KCNA.

Cable duct fixings can be seen running along the surface of missile bodies in photographs of the 11 February Plant (see Figures 6 and 7). Grey-colored fabric extrudes from the ducts (Figure 12).

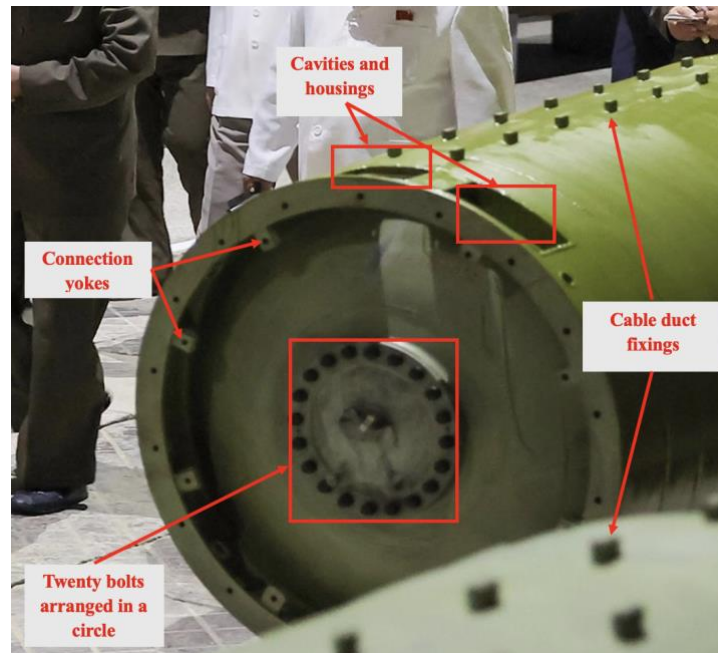
Figure 7. Forward ends of a Hwasong 11 series missile engine on display at the February 11 Plant (KCNA image of August 14, 2023). Compare the similar yokes and bolts in Figure 3. Compare also the cable duct fixings with those in Figure 13. Source: KCNA

Cavities, housings and other features such as holes were built into the outer rim of the forward end of the engine inspected in Kyiv, similar to features seen in KCNA images of 11 February Plant (see Figure 7).

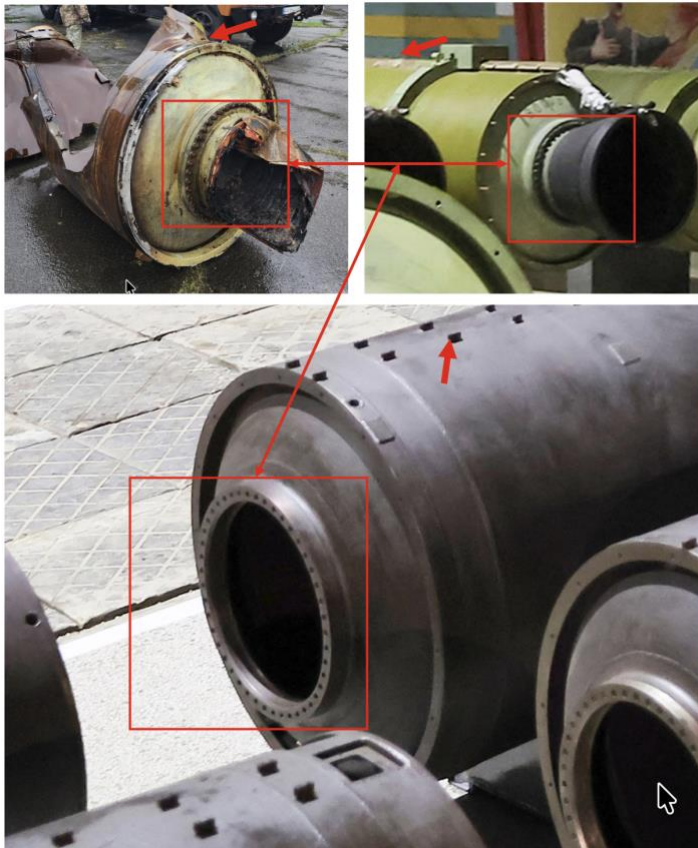
Figure 8. Rear end of missile engine: Top left, engine nozzle and 45 fixing bolts as seen on wreckage inspected in Kyiv on 17 April. And as seen on Hwasong-11 series casings in the 11 February Plant: top right, engine nozzle and fixing bolts; bottom, engine and 45 bolt holes. Thick red arrows indicate positions of cable duct fixings, further described in Figure 13 below. Sources: authors' image (top left); KCNA images broadcast on 14 August 14, 2023 (top right and bottom).

The nozzle was fastened to the rear of the engine with a total of 45 bolts (counted by the experts). A similar configuration of bolts can also be seen in images of Hwasong-11 series casings in the February 11 Plant (Figure 8).

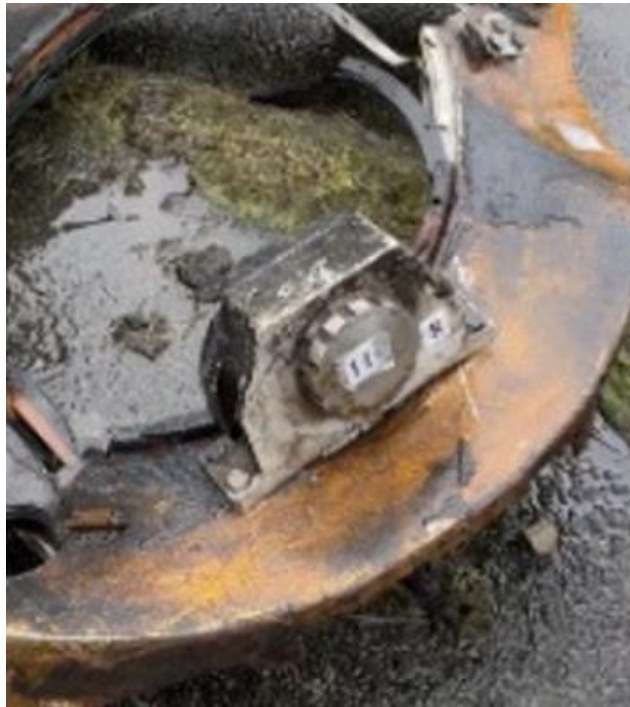
Figure 9. Trapezoid-shaped actuator attached to the base of the missile inspected in Kyiv. The base had no other attachments. Source: authors' image.

Actuators are components of steering systems mounted on the base of a missile. They are used to adjust the position of the control surfaces (or jet vanes) that sit within the engine's exhaust gases. Missiles typically have four actuators, but the wreckage examined by the Panel experts included only three, two attached to the base of the missile and the third detached. Trapezoidal in shape, they were the only mountings on the base of the missile (Figure 9).

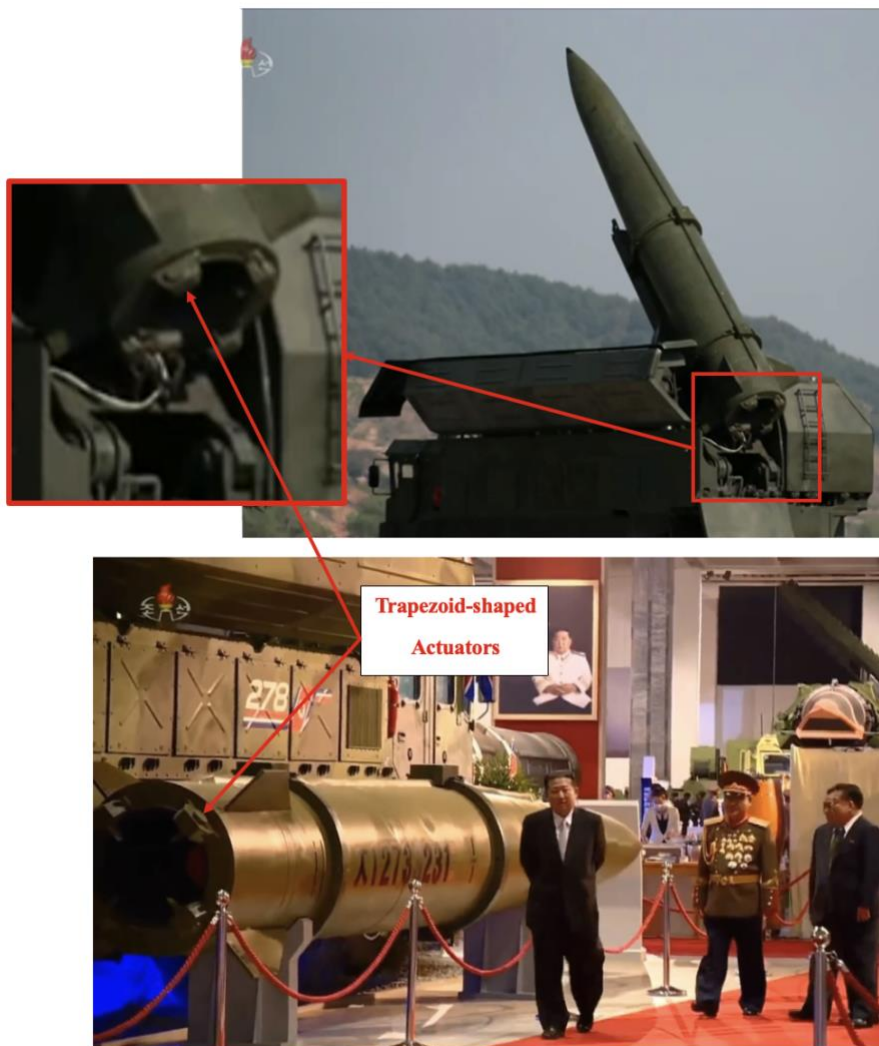
Figure 10. Trapezoid-shaped actuators seen in published images of the Hwasong 11 (KN-23). Note the absence of other mountings on the base of the missiles. Source: KCTV.

Trapezoid-shaped actuators can also be seen in photographs of Hwasong-11 series missiles being readied for firing in 2019 (Figure 10, top two images), and also in photographs taken at a “Defense Development Exhibition” in Pyongyang on October 11, 2021 (Figure 10, bottom image). In both cases, the base of the missile has no attachments other than the actuator mounts.

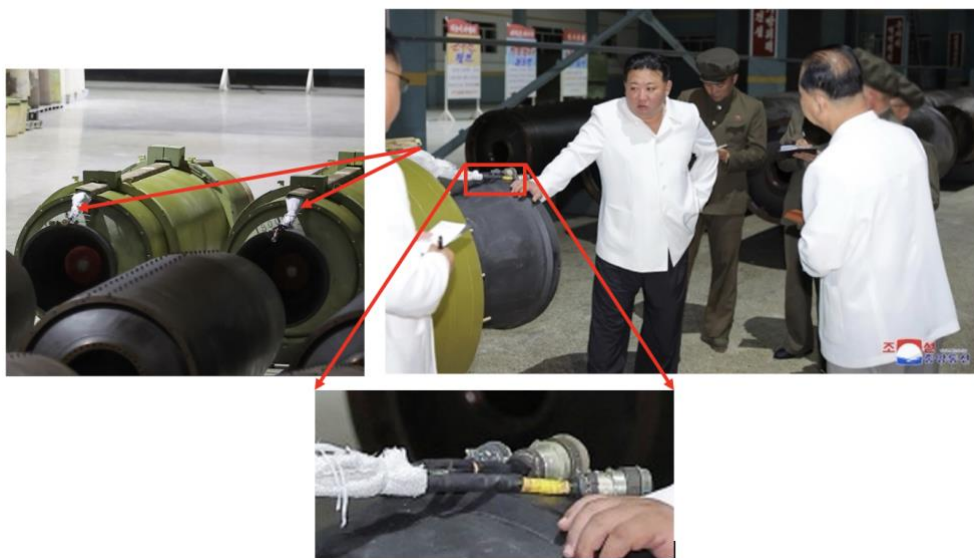
Figure 12. Grey-colored fabric inside and extruding from missile cable ducts seen in photographs inside the February 11 Plant. Source: KCNA image broadcast August 14, 2023.

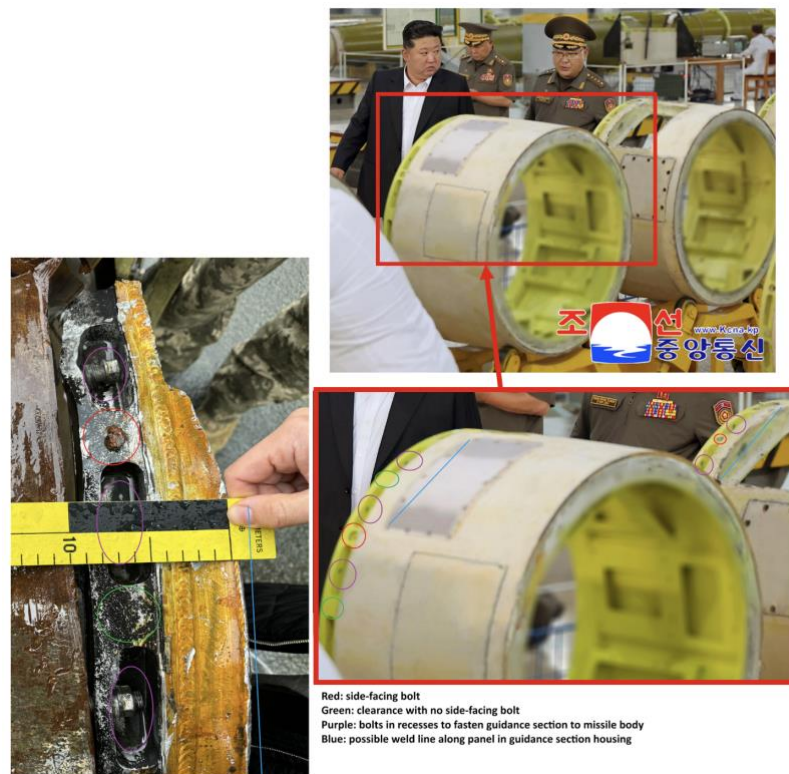
Figure 14. On the right, images published in September 2025 of the guidance section housing of Hwasong 11 series missiles. On the left, an image of the remains of the housing seen during the inspection in Kyiv. Common to both images, as indicated by colored circle. Source: author's image (left); KCNA (right).

The experts recorded the remains of the guidance housing attached to the body of the missile (Figure 14, left). Although the housing was mostly obliterated, some remains could be seen fastened to the missile body with a variety of bolts.

The orientation of the bolts can be matched with the orientation of bolts seen on images of guidance housing units of Hwasong 11 series missiles published in September 2025 (Figure 14, right).

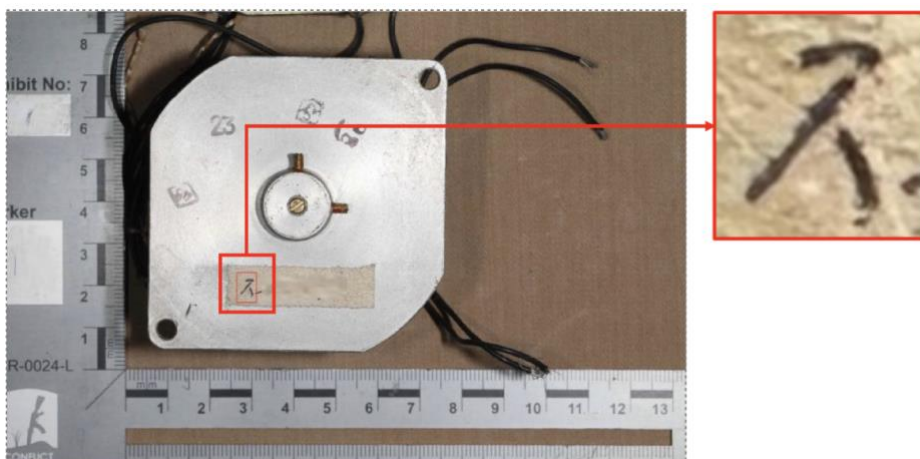
Figure 15. On the left: "A handwritten Korean 'ㅈ' character visible on a barometer, documented by CAR investigators in Ukraine on January 11, 2024" (image and caption courtesy of CAR). This character was also examined by the Panel experts in Kyiv on April 18. On the right, an enlargement of the character.

Hangul characters were present on several components of the missile inspected in Kyiv, for example a barometer was marked with the hangul

ㅈ character (Figure 15). This character was previously recorded by the DPRK Panel on a Hwasong-17 missile.¹⁹

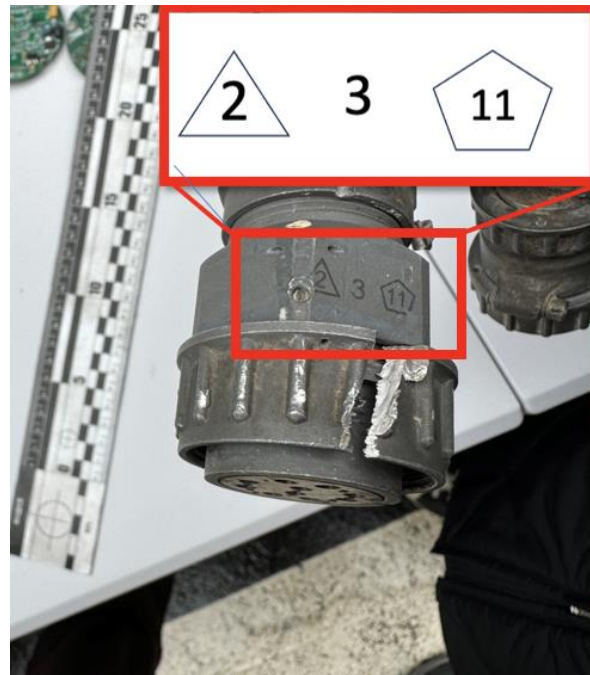
Figure 16. Cable connectors examined by the Panel experts in Kyiv. Distinctive markings highlighted. Source: author's image.

Although it was not possible to compare details, the shape of cable connectors examined during the inspection in Kyiv (Figure 16) appeared similar to those seen on images of connectors in the February 11 Plant

(Figure 12). Markings on the cable connectors in Kyiv included a triangle and a pentagon and similar markings were seen on several other components.

In 2009 DPRK military quality control certificates for small arms and light weapons were represented by a triangle, and civilian quality control certificates by a pentagon.²¹ Although Hwasong-11 series missiles do not fall into the category of small arms and light weapons, it seems probable that DPRK quality control marking conventions extend across different weapons-types.

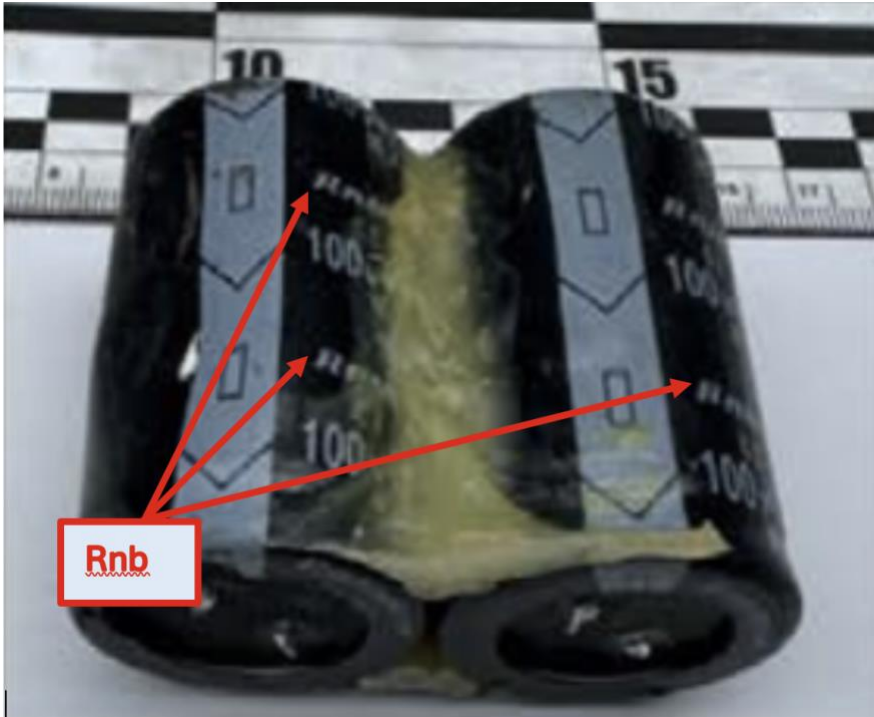
Figure 17. Component bearing the name "Rnboycon" (note that only the first three letters of this name, Rnb, can be distinguished in this image). Source: author's image.

possible examples of counterfeit foreign components. The first: bearings were recorded with markings indicating a specific manufacturer of high-quality bearings. In response to a query by the experts, that manufacturer reported that the bearings were in fact produced by an unrelated manufacturer in a different jurisdiction. The second example was capacitors bearing the name "Rnboycon" (Figure 17).

A Japanese manufacturer of capacitors with a similar name, Rubycon, posted a notice on its website that products labelled "Rnboycon" are not made by that company (Figure 18).²³

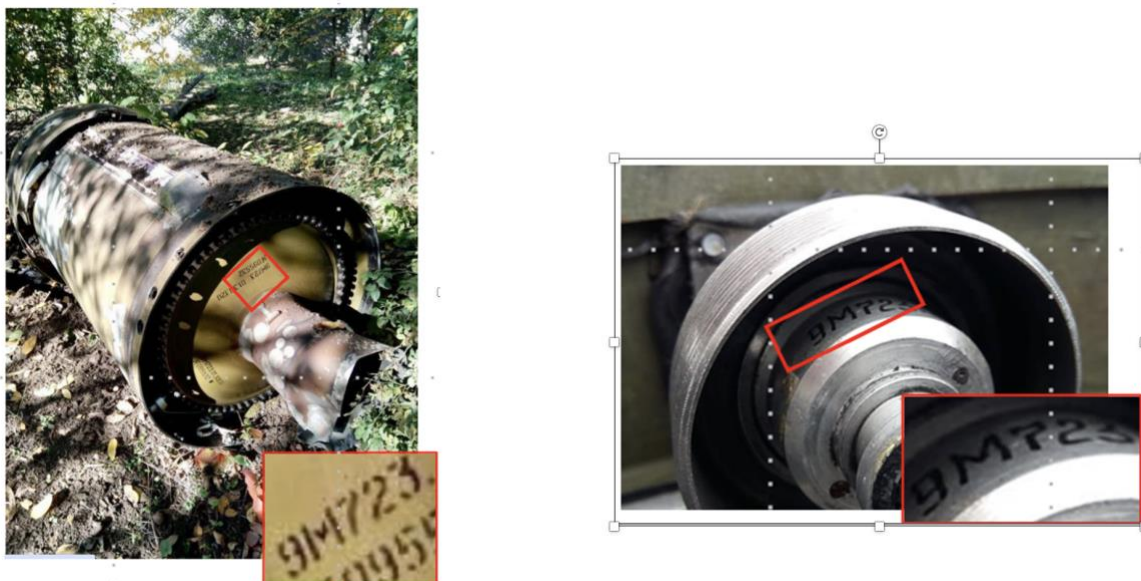
Figure 19. Examples of the 9M723 marking characteristic of Iskander M series missiles. On the left: Open Source Munitions Portal (<https://osmp.ngo/osmp4/>); on the right: "Azerbaijan claims Armenia used Iskander missiles to destroy the city of Shusha", March 31, 2021, Haqqin.az (<<https://haqqin.az/news/205714>>).

The experts checked carefully for evidence that the missile wreckage inspected in Kyiv originated in an Iskander-M series missile of Russian manufacture but found none. In addition to the trapezoidal shape of the actuators described above and the lack of additional mountings on the base of the missile, the experts saw no markings characteristic of Iskander-M series missiles, such as "9M723" (Figure 19), nor any other indications of a possible Russian origin such as Cyrillic script.
