## SOME ENGINEERING GEOLOGIC EFFECTS OF THE 1964 ALASKA EARTHQUAKE

Wallace R. HANSEN (\*)

### ABSTRACT

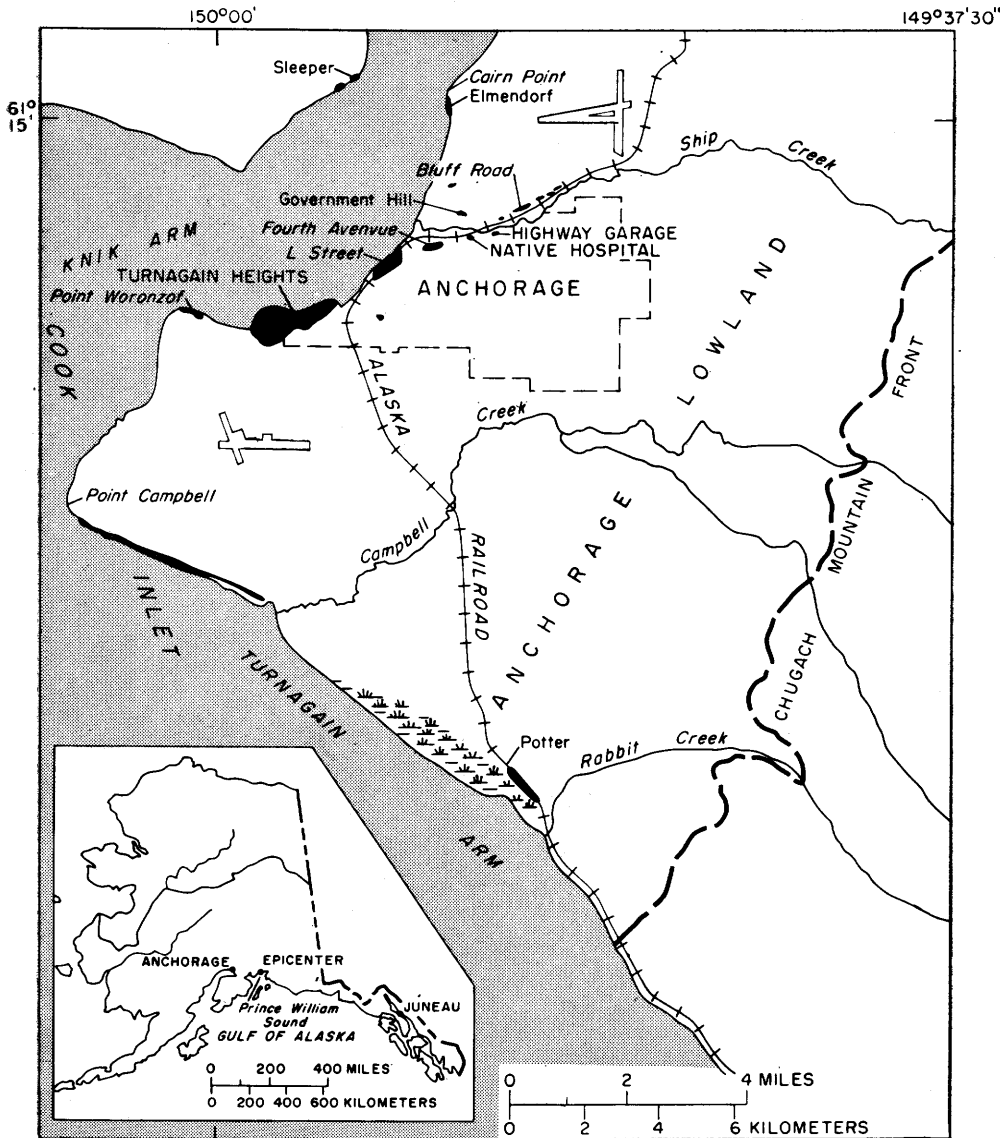
FIG. 1. — Map showing locations of earthquake-caused landslides in the Anchorage area, Alaska, with inset showing epicenter.

Landslides were the most spectacular manifestations of earthquake damage at Anchorage, and they occurred in many places (fig. 1). The slides took many forms in several types of earth materials. The most destructive ones, in terms of property damage, resulted from failures in the Bootlegger Cove Clay. Serious failures, however, also occurred in glacial till, delta deposits, tidal sediments, and dune sands.
