## THE APPLICATION OF ENGINEERING GEOLOGY TO THE CONSTRUCTION OF DAMS IN THE UNITED KINGDOM

J. L. KNILL (\*)

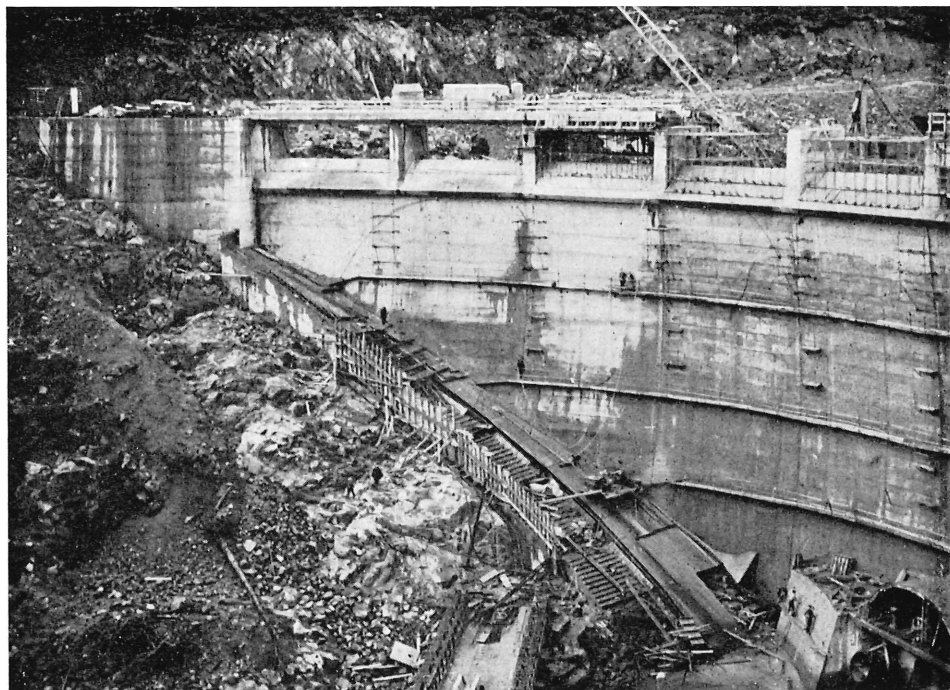
PLATE 1. — *General view of right bank of Monar dam during construction.*

The only major double curvature arch dam in the country is at Monar (Plate I) 50 km west of Inverness. The dam is 38 m in maximum height and has a theoretical chord to height ratio of 3.3. The gorge at Monar is eroded within micaceous psammitic granulites with thin micaceous layers (Henkel, Knill, Lloyd and Skempton, 1964; Roberts, Wilson and Wiltshire, 1965). The basis of design of the arch was that the modulus of deformation of the concrete and rock founda-

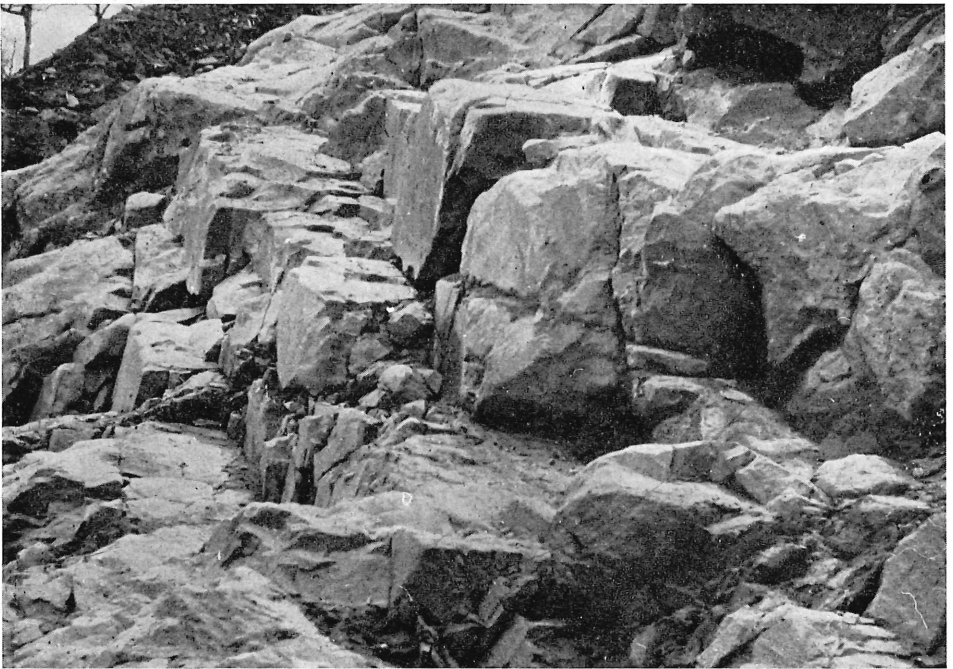
PLATE 2. — Detail of rock structure on right bank with upstream-dipping joints (dipping towards camera).

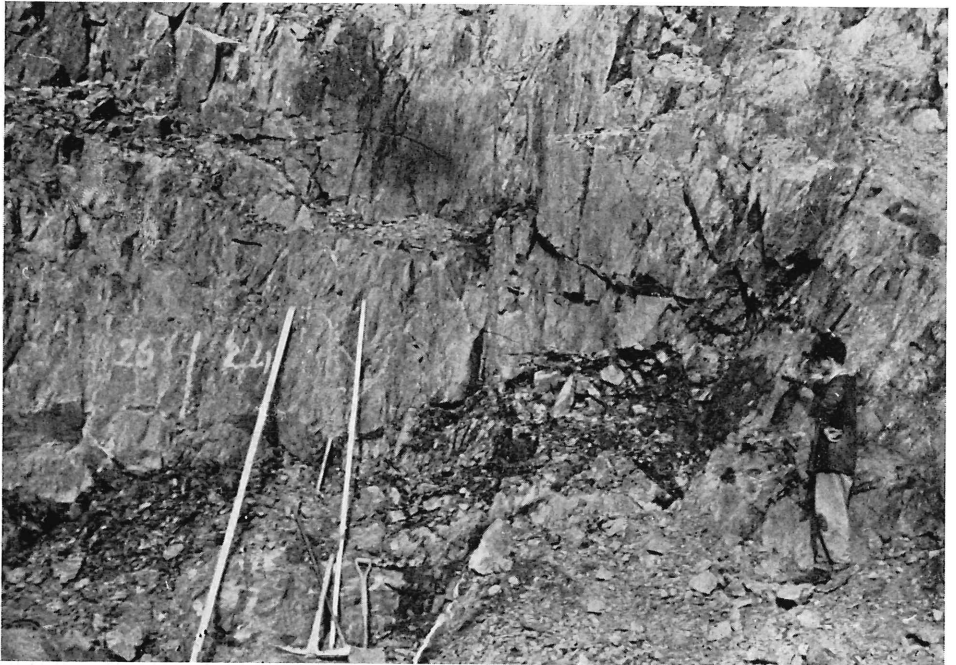
PLATE 3. — Deep glacial shears at 10 m depth in slaty tuffs at Wet Sleddale dam.

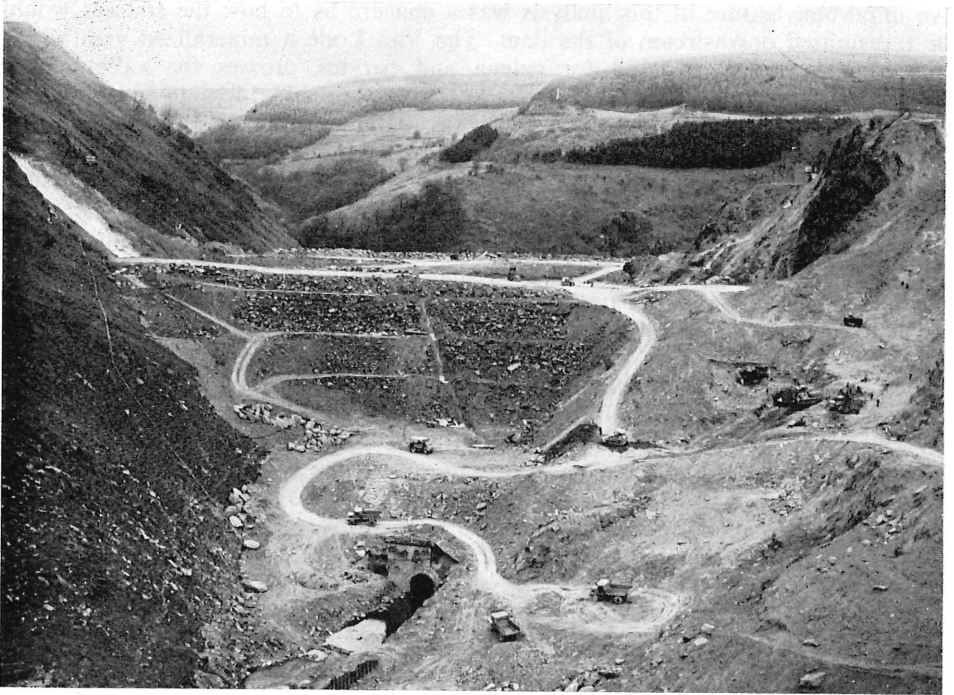
PLATE 4. — *General view of Brianne rock fill dam under construction.*

As at Clywedog, there was uncertainty as to the extent of remedial work which might be required on the dam abutments to form arch dam foundations. Suitable core material was available from a glacial moraine 11 km upstream in the reservoir area, but there were no suitable sources of concrete aggregate locally available in the quantities required for a major concrete dam. At the dam site the River Towy changes sharply in direction and this permitted an overflow chute spillway to be cut into rock adjacent to the dam. In view of these site circumstances, a central core rockfill design was selected for the site (Plate 4).

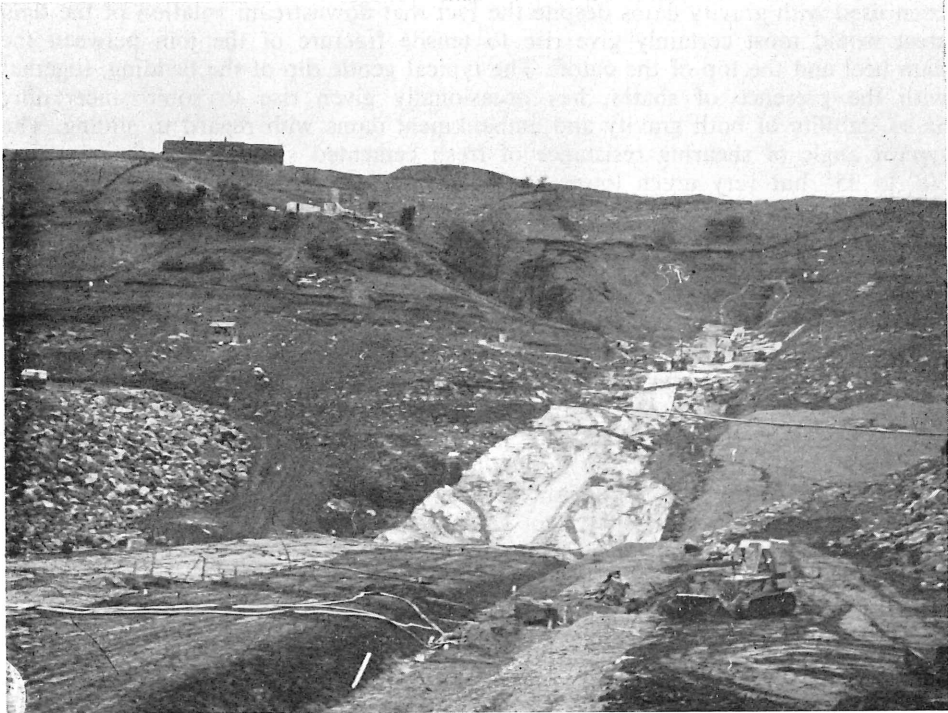
PLATE 5. — *Left bank of Scammonden dam during construction illustrating core, filters and rockfill in foreground and cutoff zone in middle distance.*

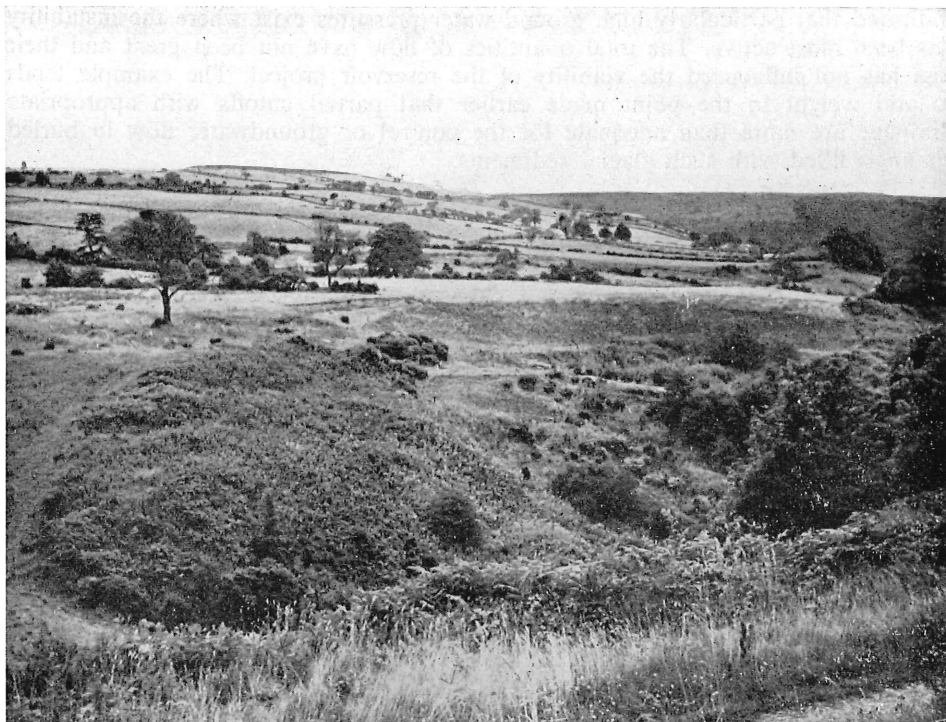
PLATE 8. — *View of slips in glacial lake deposits in buried channel immediately downstream of the left bank of the Cod Beck dam.*

The Cod Beck dam, the last of the three dams on buried channels to be considered, was constructed in the period 1949-1953 and impounded in 1953; the embankment is a conventional structure 30 m in height. During construction it was established that the left flank of the dam was located at the edge of a pre-glacial channel and the dam was terminated in a partial cutoff on that side (fig. 9). The Cod Beck valley contains several degraded slips, some of which contain evidence of recent activity both in the Lias shale bedrock and the glacial sediments within which the present river channel has been formed. During impounding and before filling was completed, an old slip downstream of the dam underlain by the glacial deposits was reactivated (Plate 8). Active movement occurred for the next two years and drains were installed which proved successful until they

deteriorated and further movements occurred in 1961. The movements were eventually arrested in 1965 at a much flatter slope than existed prior to impounding. Further investigations were carried out in 1970 and these were supplemented by the installation of additional drains.
